Copper Fox Metals Inc.

Schaft Creek Project: Fisheries Baseline 2008

Fisheries Baseline 2008

Project #1039-001-06

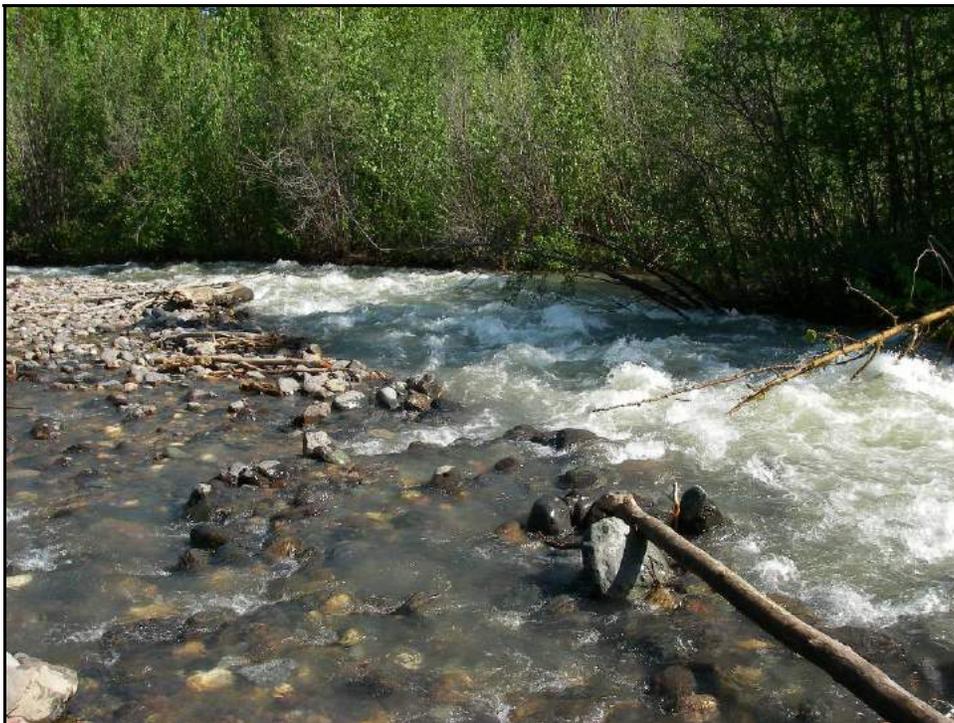
Plate 3.1-5. A downstream view of cascade habitat present within the Walkout Creek Watershed.

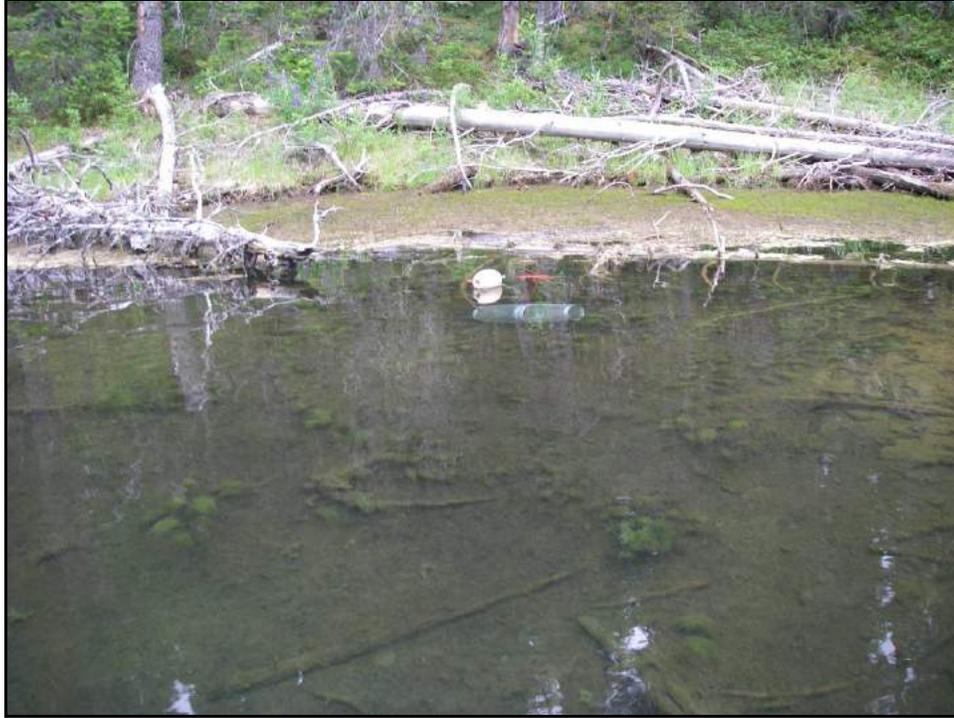
Plate 3.1-11. Minnow trap set in the lagoon section of the lake. Note the large woody debris and algae providing cover for fish.

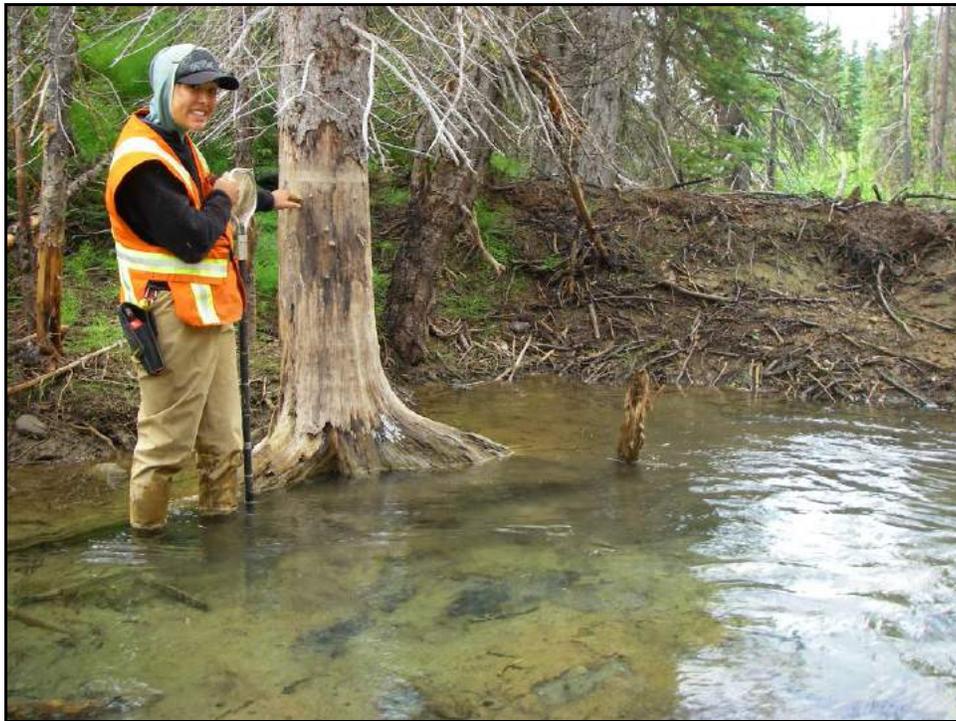
Plate 3.2-3. Reach 2 of Start Creek flows through a former beaver pond. An assistant points out the old pond level and the breached dam is visible in the background.

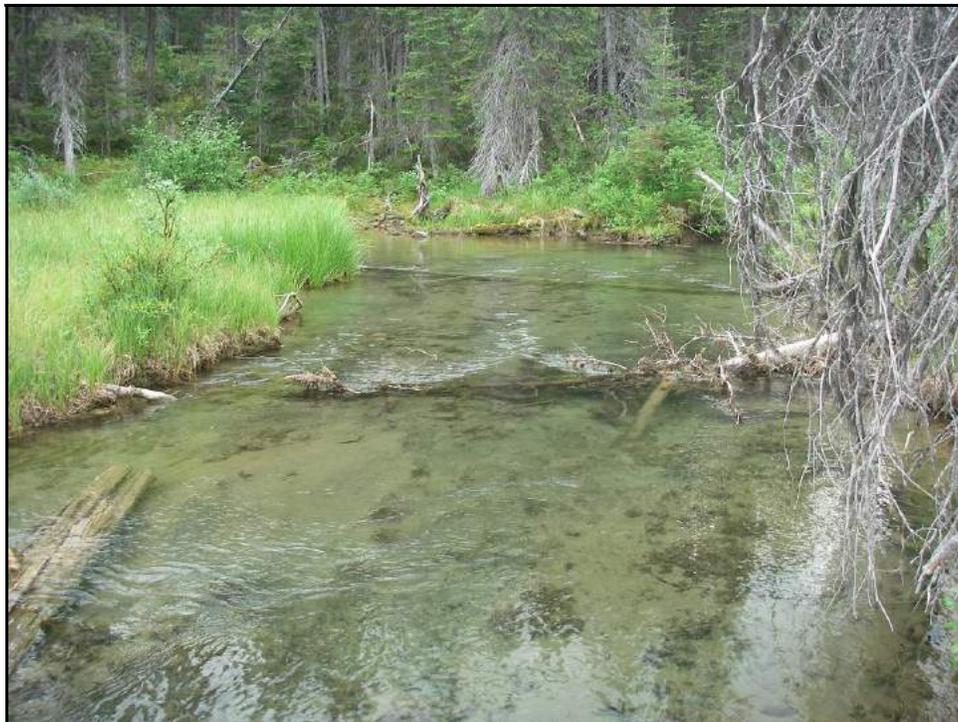
Plate 3.2-6. Reach 4 of Start Creek, looking downstream at the wide, large-channel morphology.

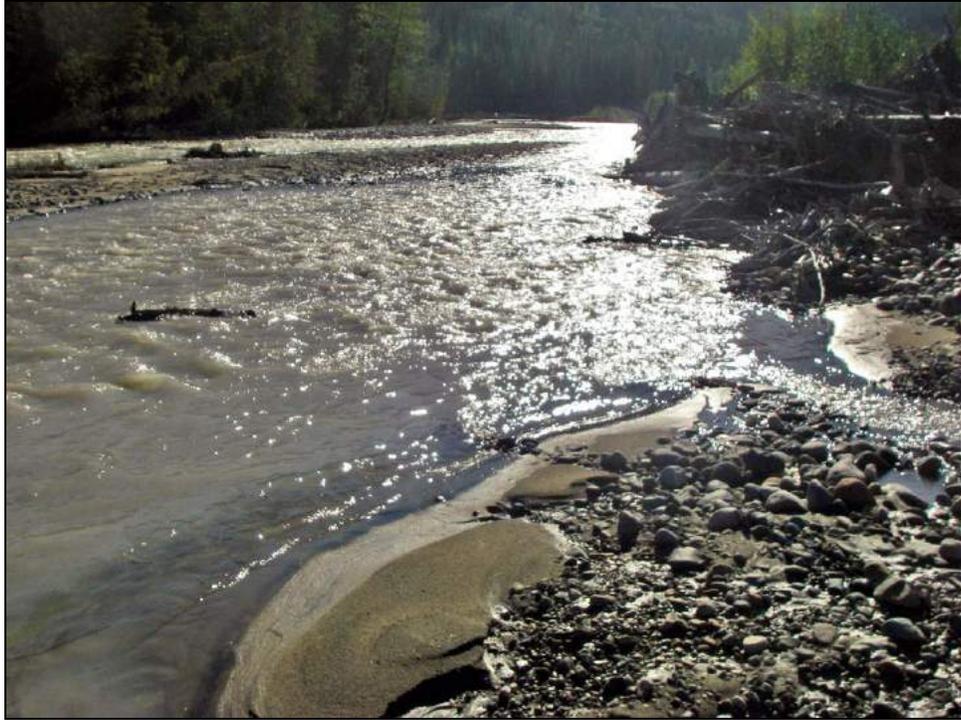
Photo 1. Dammed pool was actually just slow water - shallow plunge pool (0.3

m) and scour pool in background next to SWD.
